WAKEFIELD PUBLIC SAFETY BUILDING

ANNUAL TOWN MEETING

SPRING 2018

INDEPENDENT STUDY PUBLIC SAFETY BUILDING

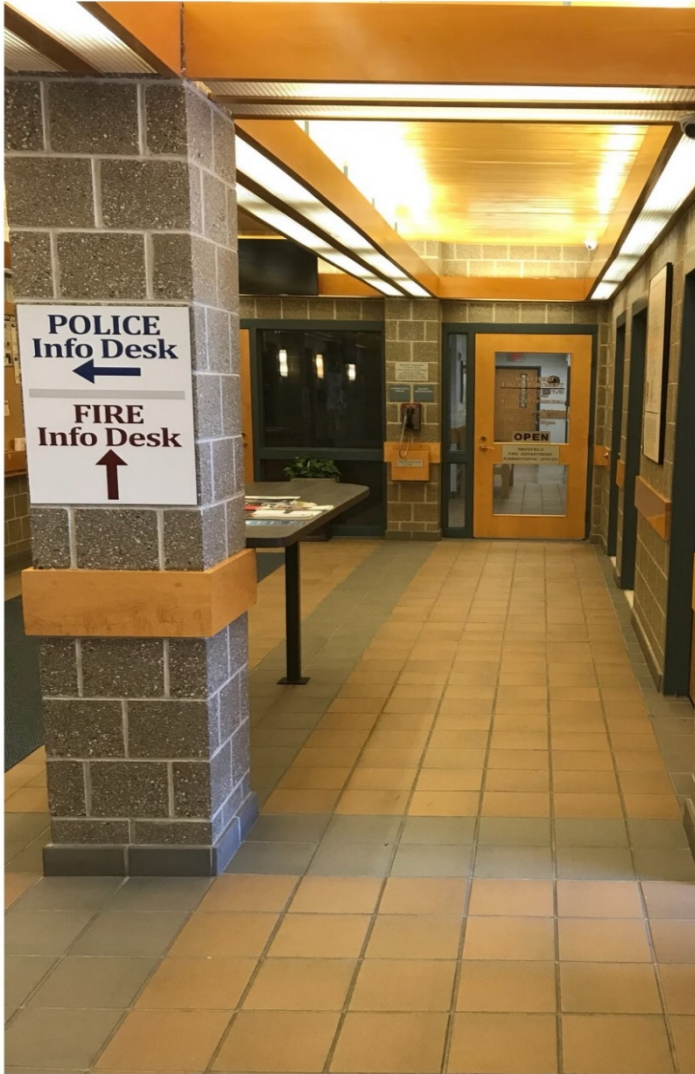
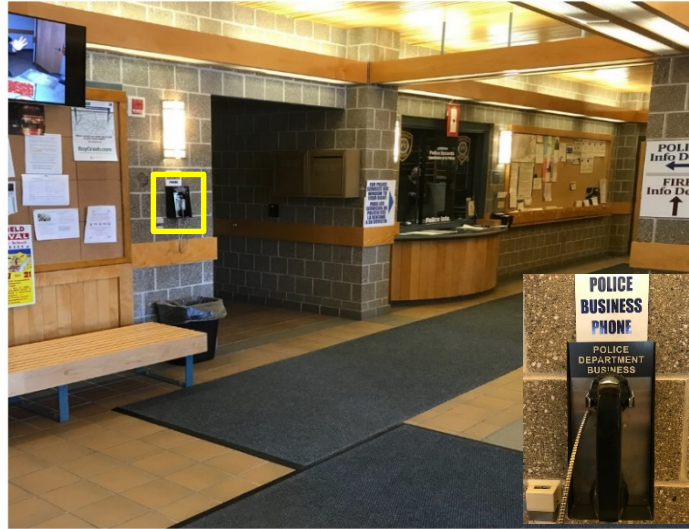
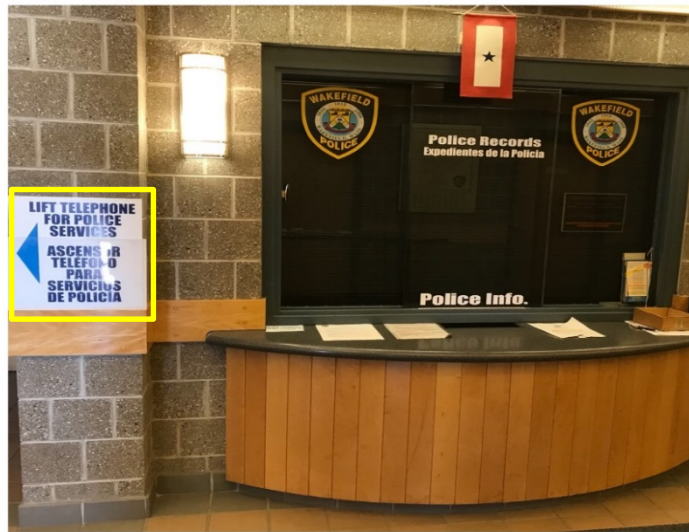
EXISTING LOBBY

- Entry sequence: Speaking to either FD or PD personnel is not a simple process, we have had to add multiple signs.
- PD Records Officers constantly directing walk-ins looking for FD.
- Citizen needing immediate help when Records Office is closed must rely on a telephone

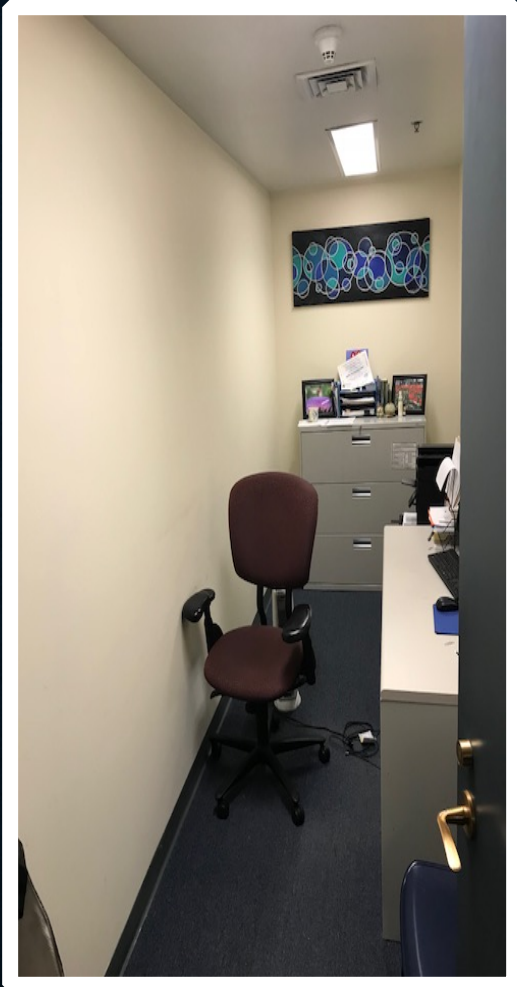
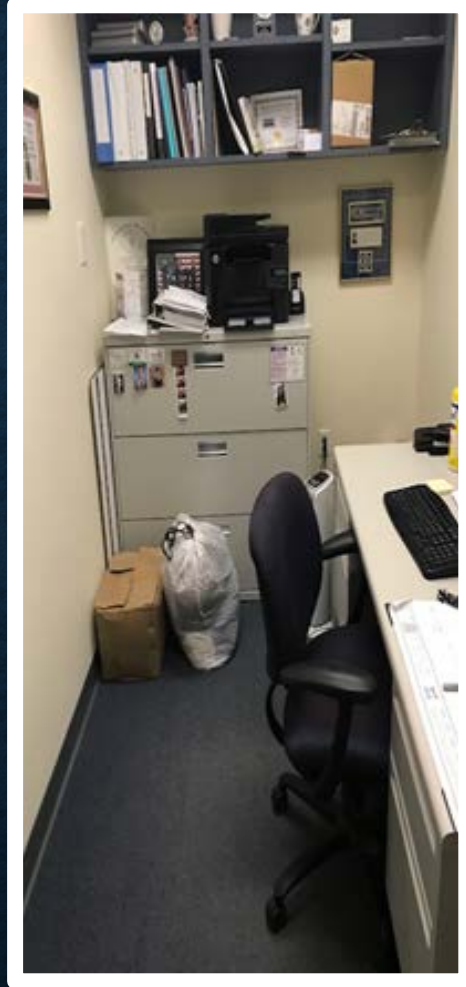
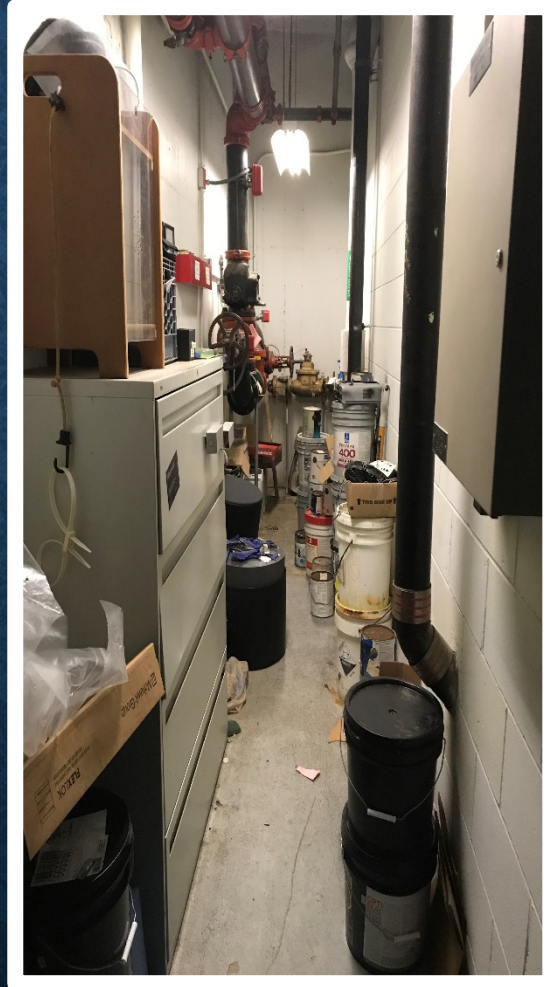
EXISTING PD FIRST LEVEL

- Locker Rooms – Poor use of space, unusable lockers due to columns. No room for additional officers
- Two small storage rooms (5' wide) in basement originally used for armory work room and arms storage now occupied by personnel
- K9 equipment/gear stored in Water Services room in garage
- Roll Call Room – Far too small for daily briefings/training

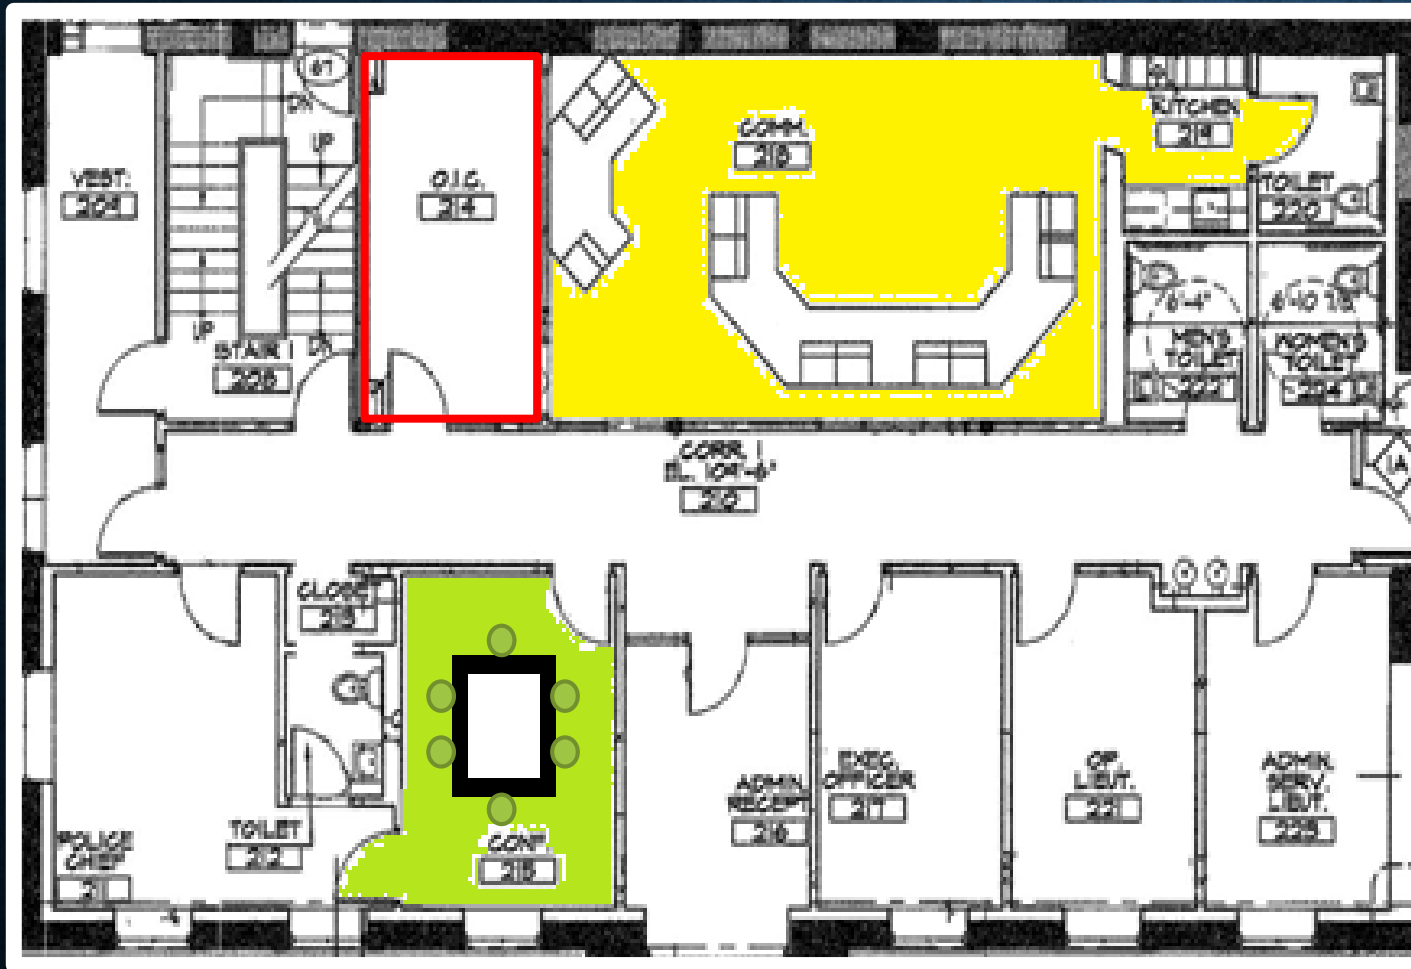
EXISTING SECOND FLOOR PLAN

- Location of Dispatch on upper level does not meet the needs of the Community
- Small Sergeants Office converted into needed patrol equipment room
- Administrative offices are in busiest area, not conducive to privacy/confidentiality
- Only PD Conference Room is far too small, holds 4-6 people. Unable to hold meetings

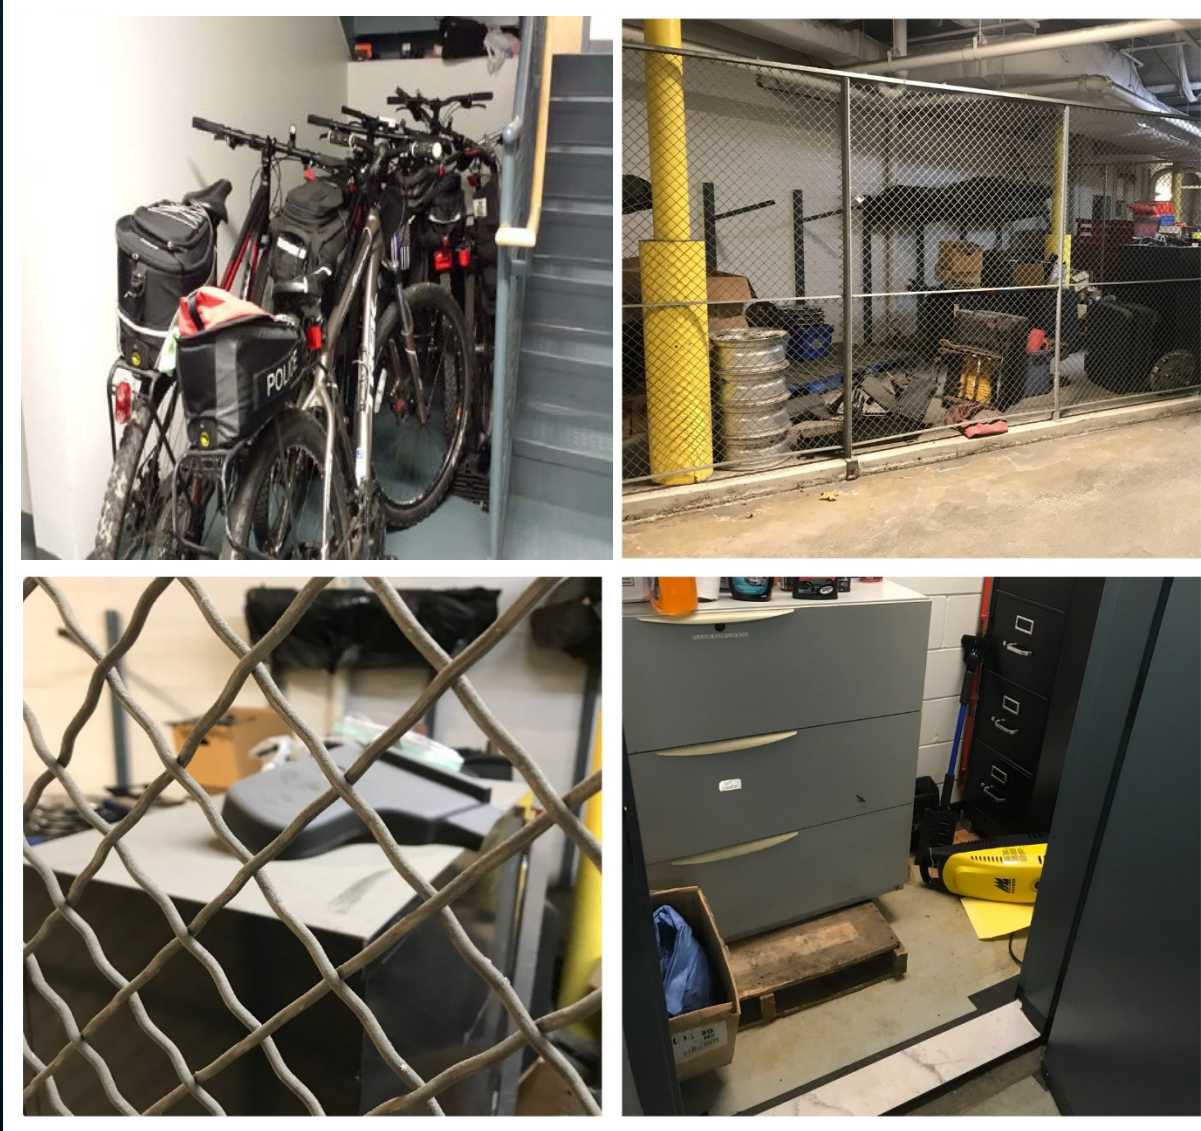
STORAGE

- Bicycles and other equipment used daily stored in hallways.
- Recovered Property Room is unusable, items become filthy.
- Some items up on blocks due to water damage.
- We do have other equipment stored off-site.

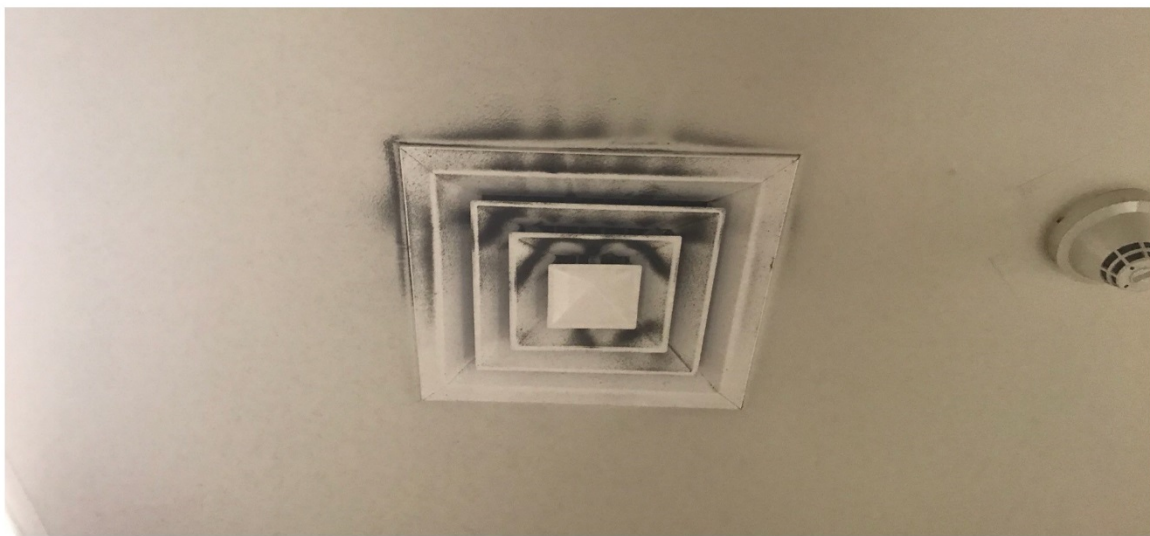
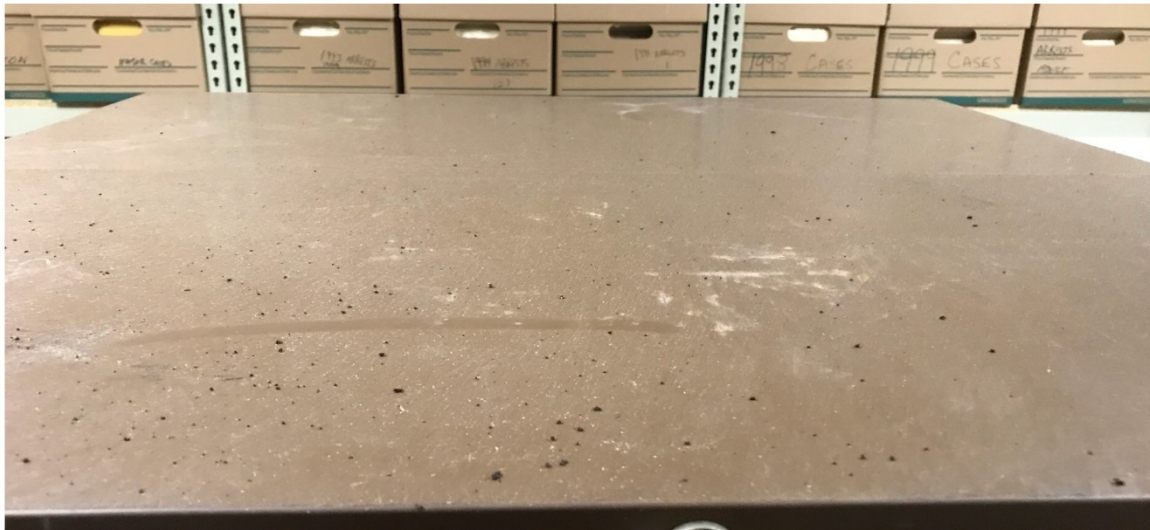
VENTILATION SYSTEM

- Air duct system has had black soot flowing through for many years.

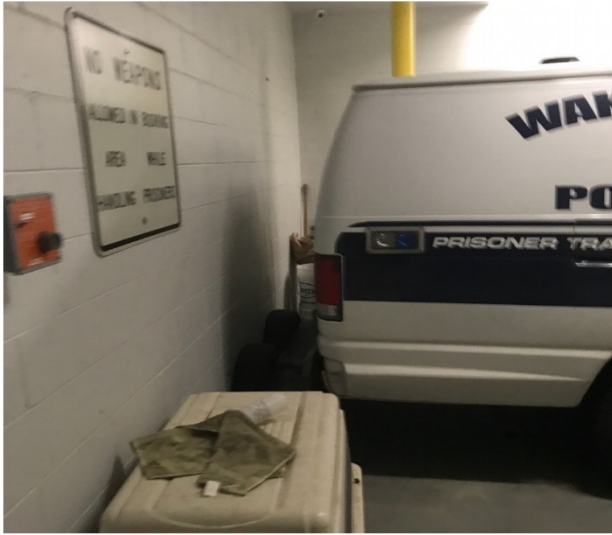
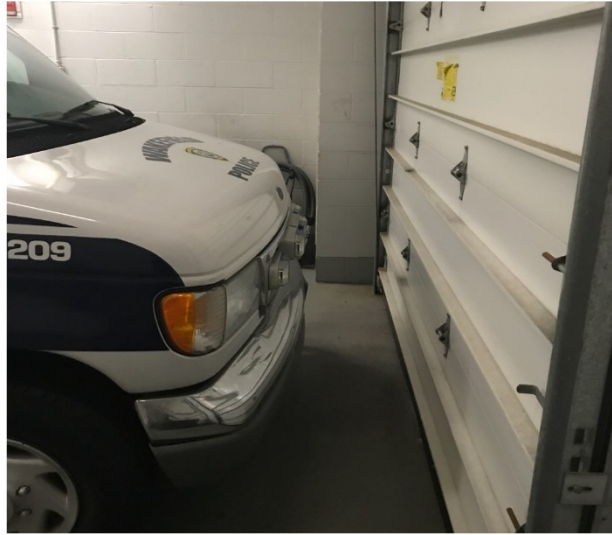
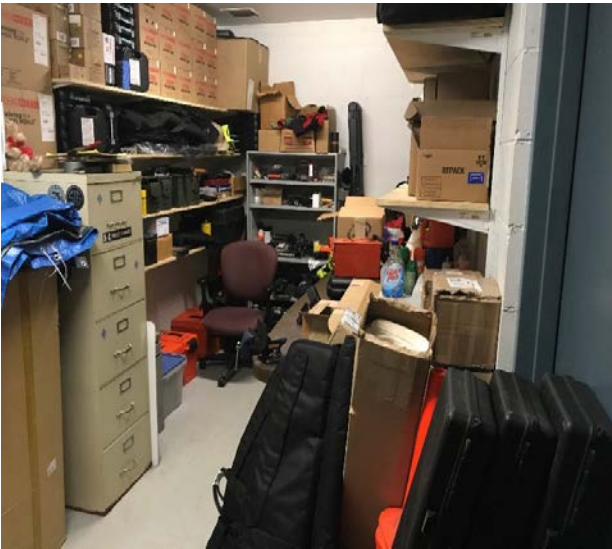
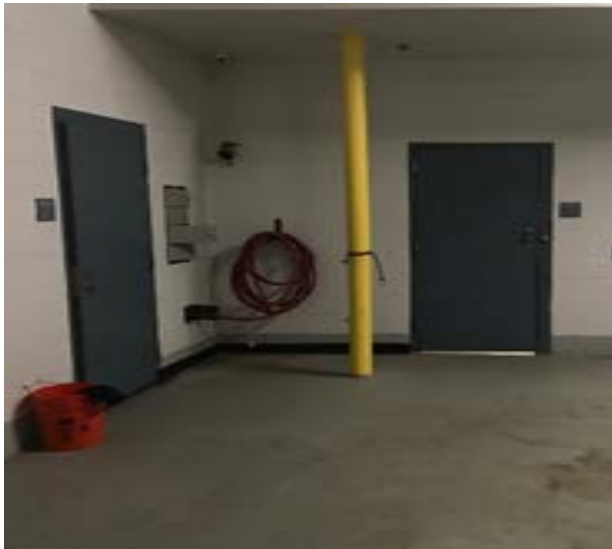
PRISONER BAY

- Prisoner Bay too small and is a safety issue.
- Security door must remain open in order to allow enough clearance to remove prisoner from rear compartment.
- Support columns were used as opposed to beams.
- Bicycle Room had to be converted into Armory due to lack of space, and it is not up to code.

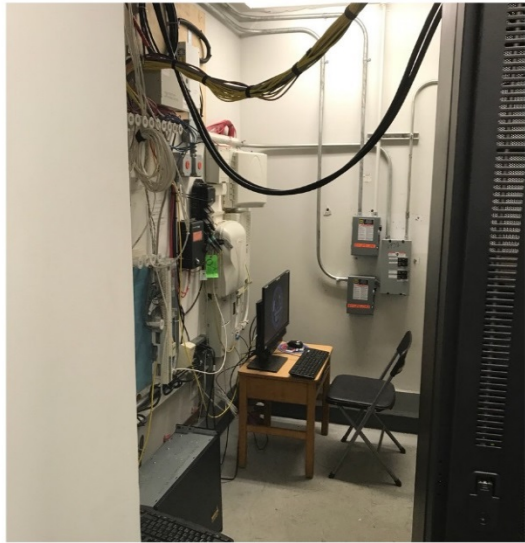
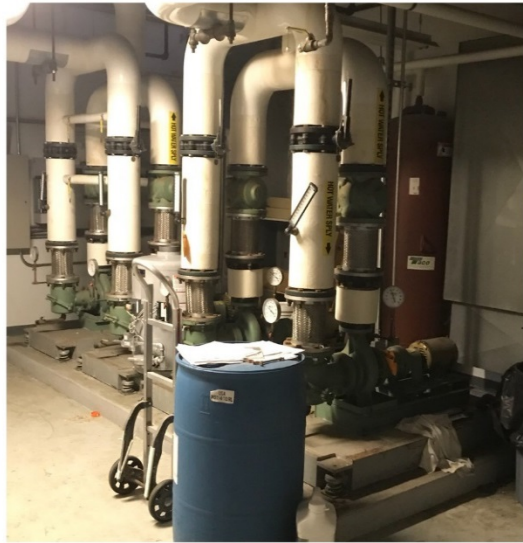
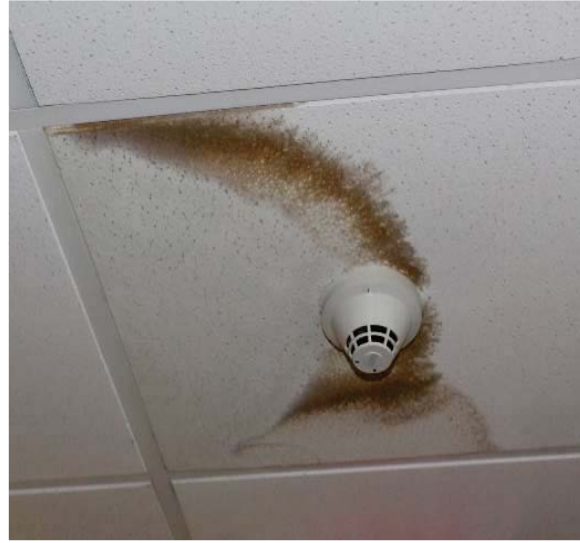
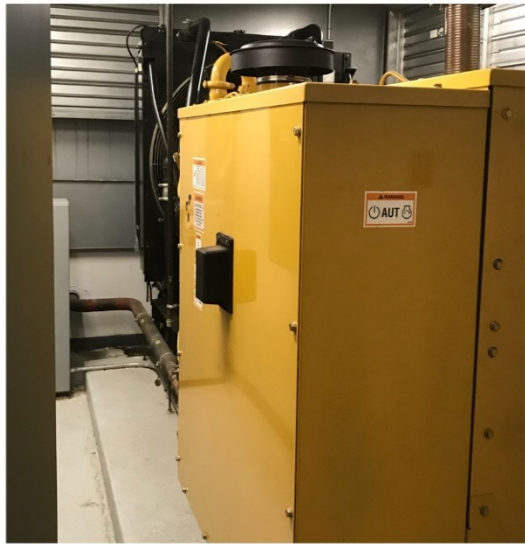
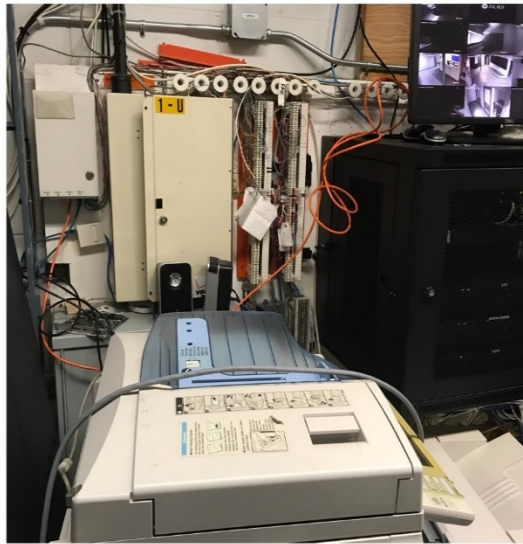
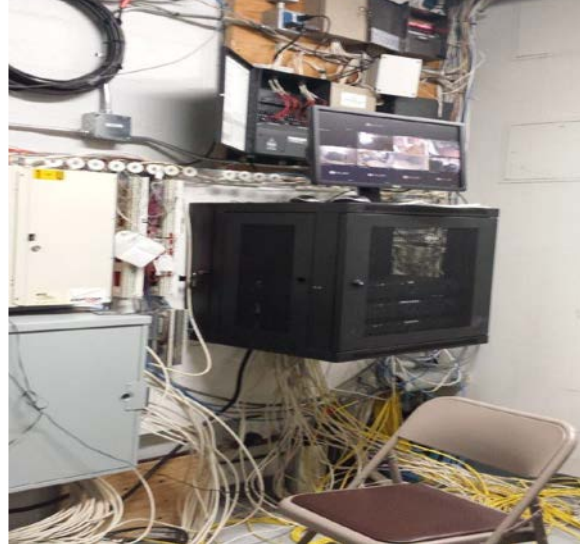
2003 POLICE BUILDING "ADDITION"

- Most of the additional space from the previous renovation resulted in unusable space for PD operations.
- 911 Room, Electrical Room, Water Room, Generator Room, Radio System Room, IT Room, all for the Public Safety Building are located on PD side.
- Water leaks from roof in several areas, including IT Equipment room.
