PUBLIC SAFETY BUILDING FEASIBILITY STUDY

WAKEFIELD, MASSACHUSETTS JUNE 26, 2017

FINAL REPORT

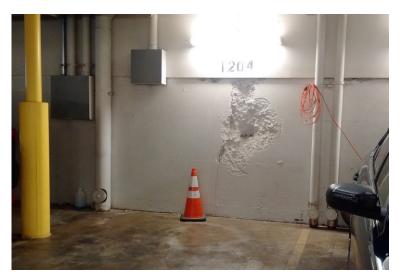
Photo 1, Damaged Concrete Wall

3a) There is a dent in the northern concrete wall of the old police building on the first floor (Photo 1). This is a bearing wall the damaged should be repaired.

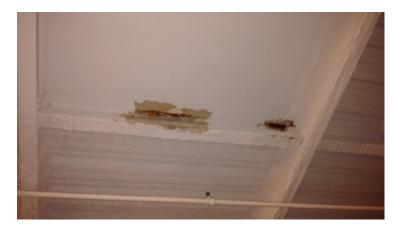
Photo 2, Rebar Corrosion in Concrete Deck

3b) Steel beam and metal deck corrosion were observed at a few areas of the second floor framing above the parking area, likely due to water infiltration through the floor of sally port above (Photos 2 and 3). Further inspection of the deck and steel condition will be required to evaluate the condition of deck and beam. For surface rust, the steel will need to be cleaned with wire brushed and painted. If section loss has occurred, steel reinforcement may be required.

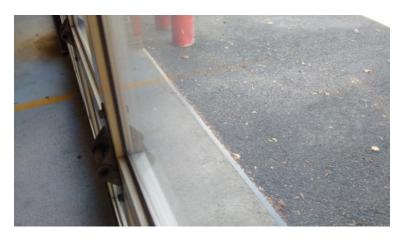
Photo 4, Grade Difference at Threshold

3c) At the apparatus room entrance, the exterior grade outside the threshold has settled (Photo 4). To provide a smooth grade transition a concrete approach slab will need to be constructed.
